polflame® – High-Quality

Repairs at our Neubeckum Facility

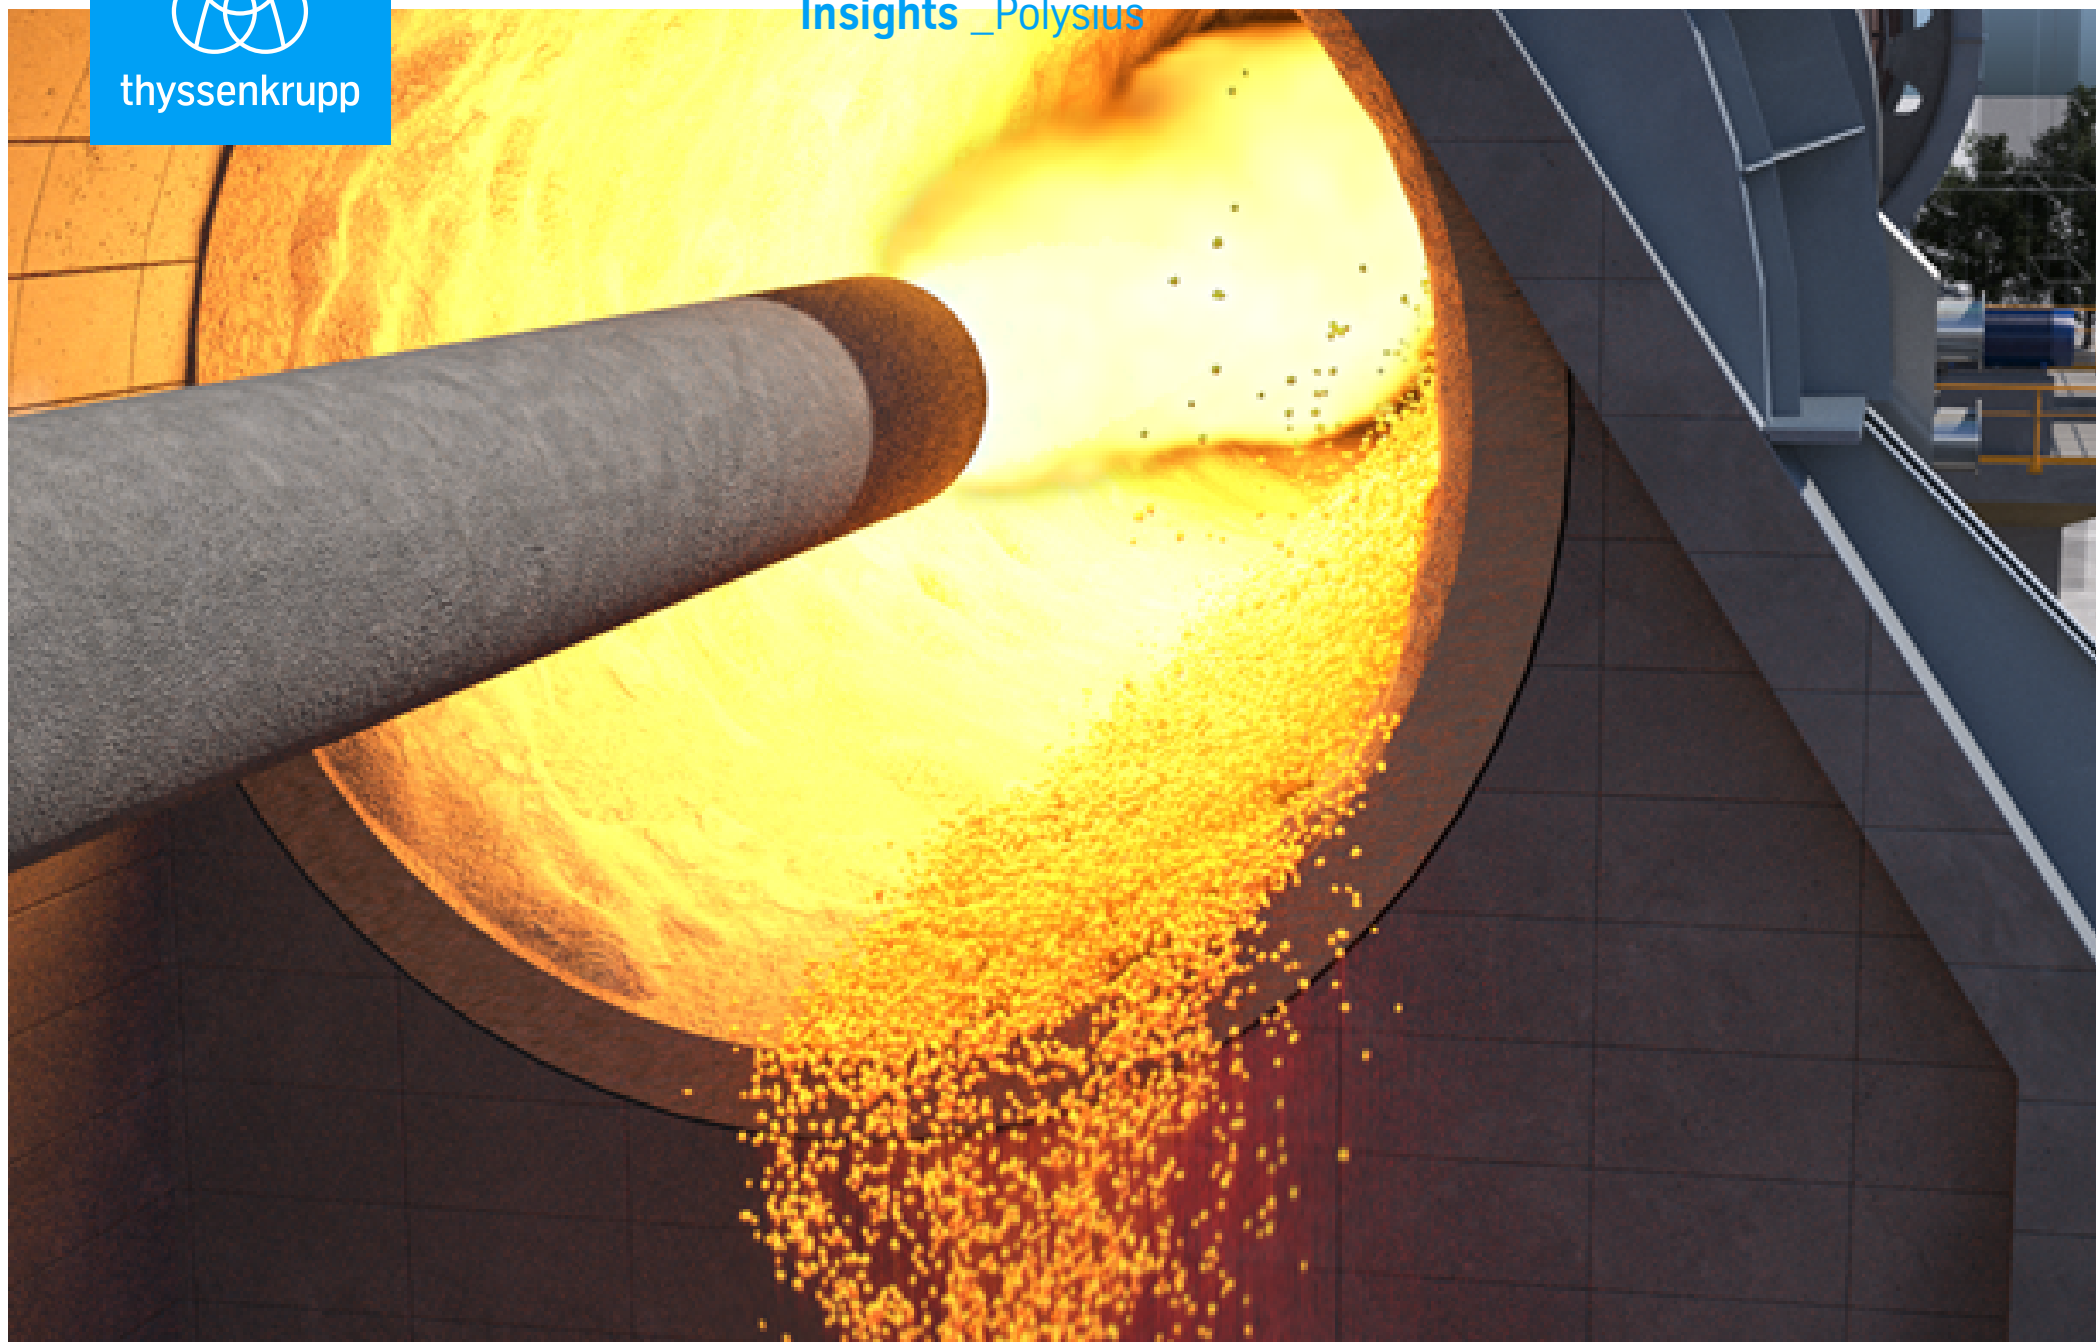
The polflame® clinkering zone burner from thyssenkrupp Polysius is a well-established component of the global cement industry. Since its introduction in 1997, this “long-running burner” has been used in more than 200 cement plants worldwide. It reduces fossil fuel consumption while enabling the use of alternative fuels, and at the same time contributes to increased efficiency and improved clinker production quality. However, after years of operation, heat or wear damage may occur.

The repair included the **disassembly of defective components, replacement of blocked bolts, and reassembly of the burner tip, nozzle adjustment, jacket pipe, mouthpiece, and burner tip disc**. In addition, new nozzles with housing were installed.

Special tools enabled the precise replacement of large pipe segments, while the use of dies, cranes, and other lifting equipment ensured safe and efficient handling of the burner. Heavy loads, particularly the weight of the burner tip, were precisely aligned and expertly welded.

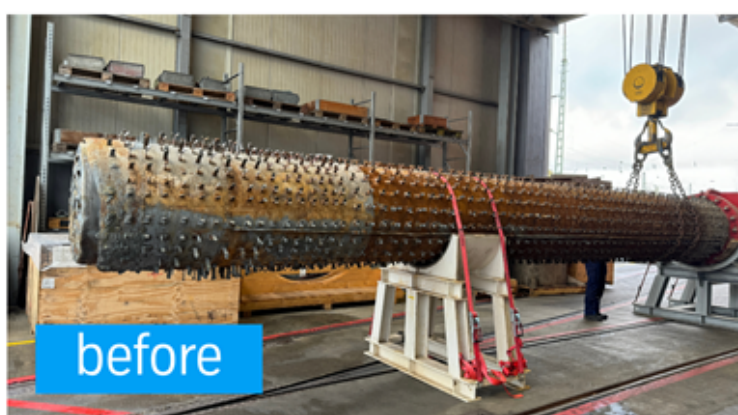
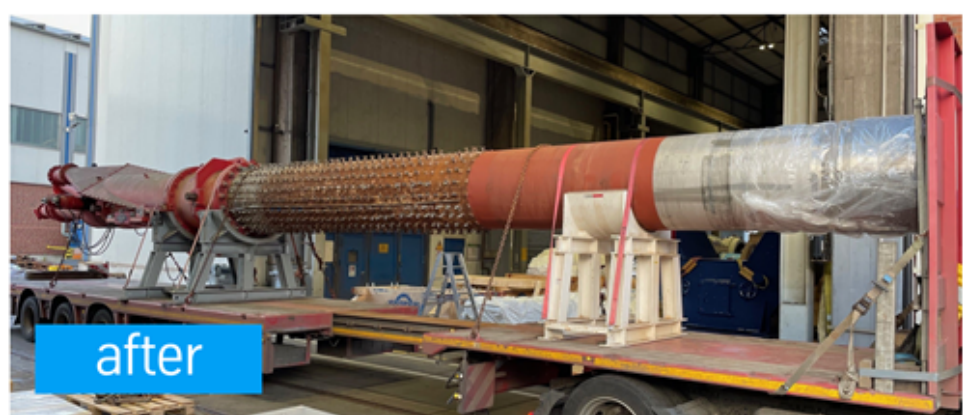
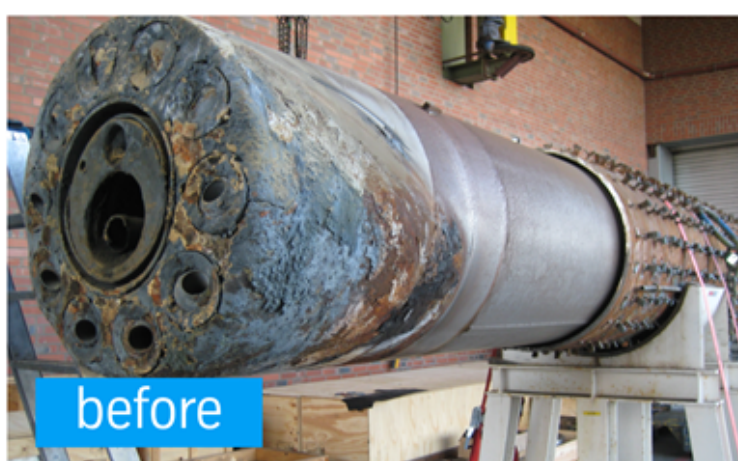
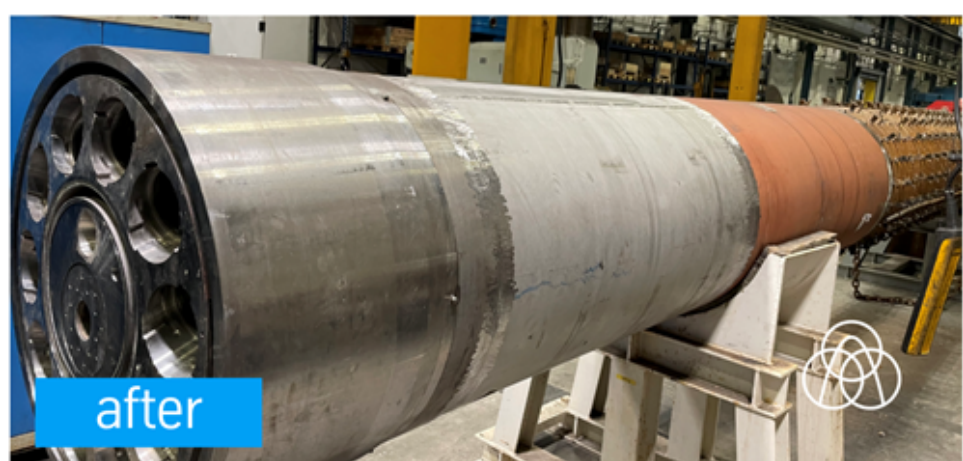
A few months ago, a customer commissioned us to **repair their clinkering zone burner** after a typical heat damage incident.
